Manhole Inspection Summary

Manhole # S35W__065MH

Insp Date: 9/18/08 9:28 AM

Location Address: **61 e heath st**

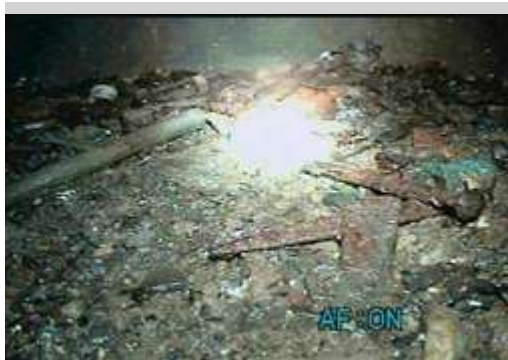
Defect 5

Condition: ☐ Sound ☐ Cracked ☐ Root Intrusion ☐ Deteriorated ☐ Leaks ☒ **Debris**

channel debris

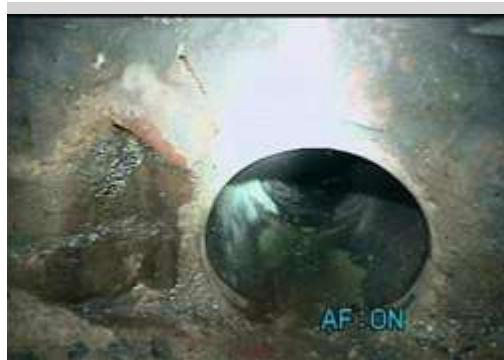
Defect 4

Infiltration: ☐ None ☐ Joint ☐ Cracks ☐ Mortar ☐ Roots ☒ **Wall**

infiltration in barrel

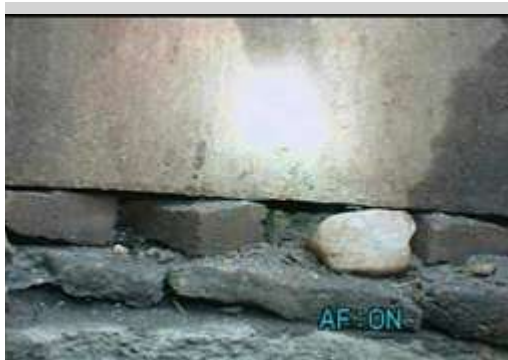
Defect 3

Condition: ☐ Sound ☐ Cracked ☐ Root Intrusion ☒ **Loose Brick** ☐ Deteriorated

loose bricks, frame adj

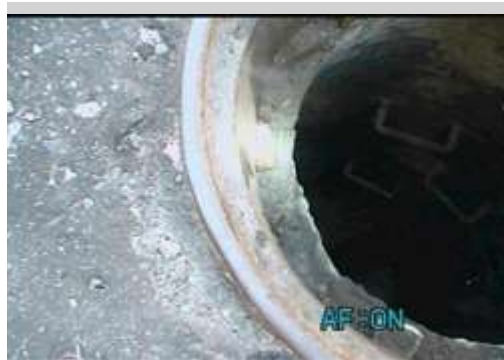
Defect 2

Offset: **2.5** (in.)

offset

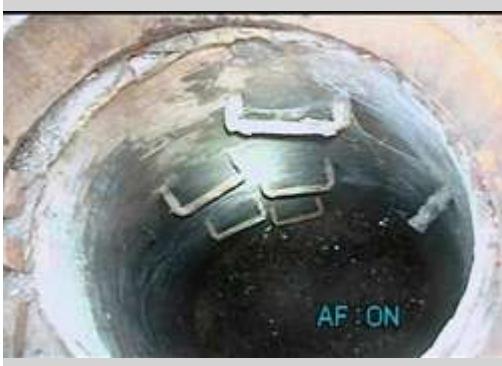
Defect 1

Count: **5** Missing: **0** ☒ **Corroded**

cor. steps
